# PHASE I MILESTONE INSPECTION

Princeton Place 2 at Wiggins Bay Condominiums

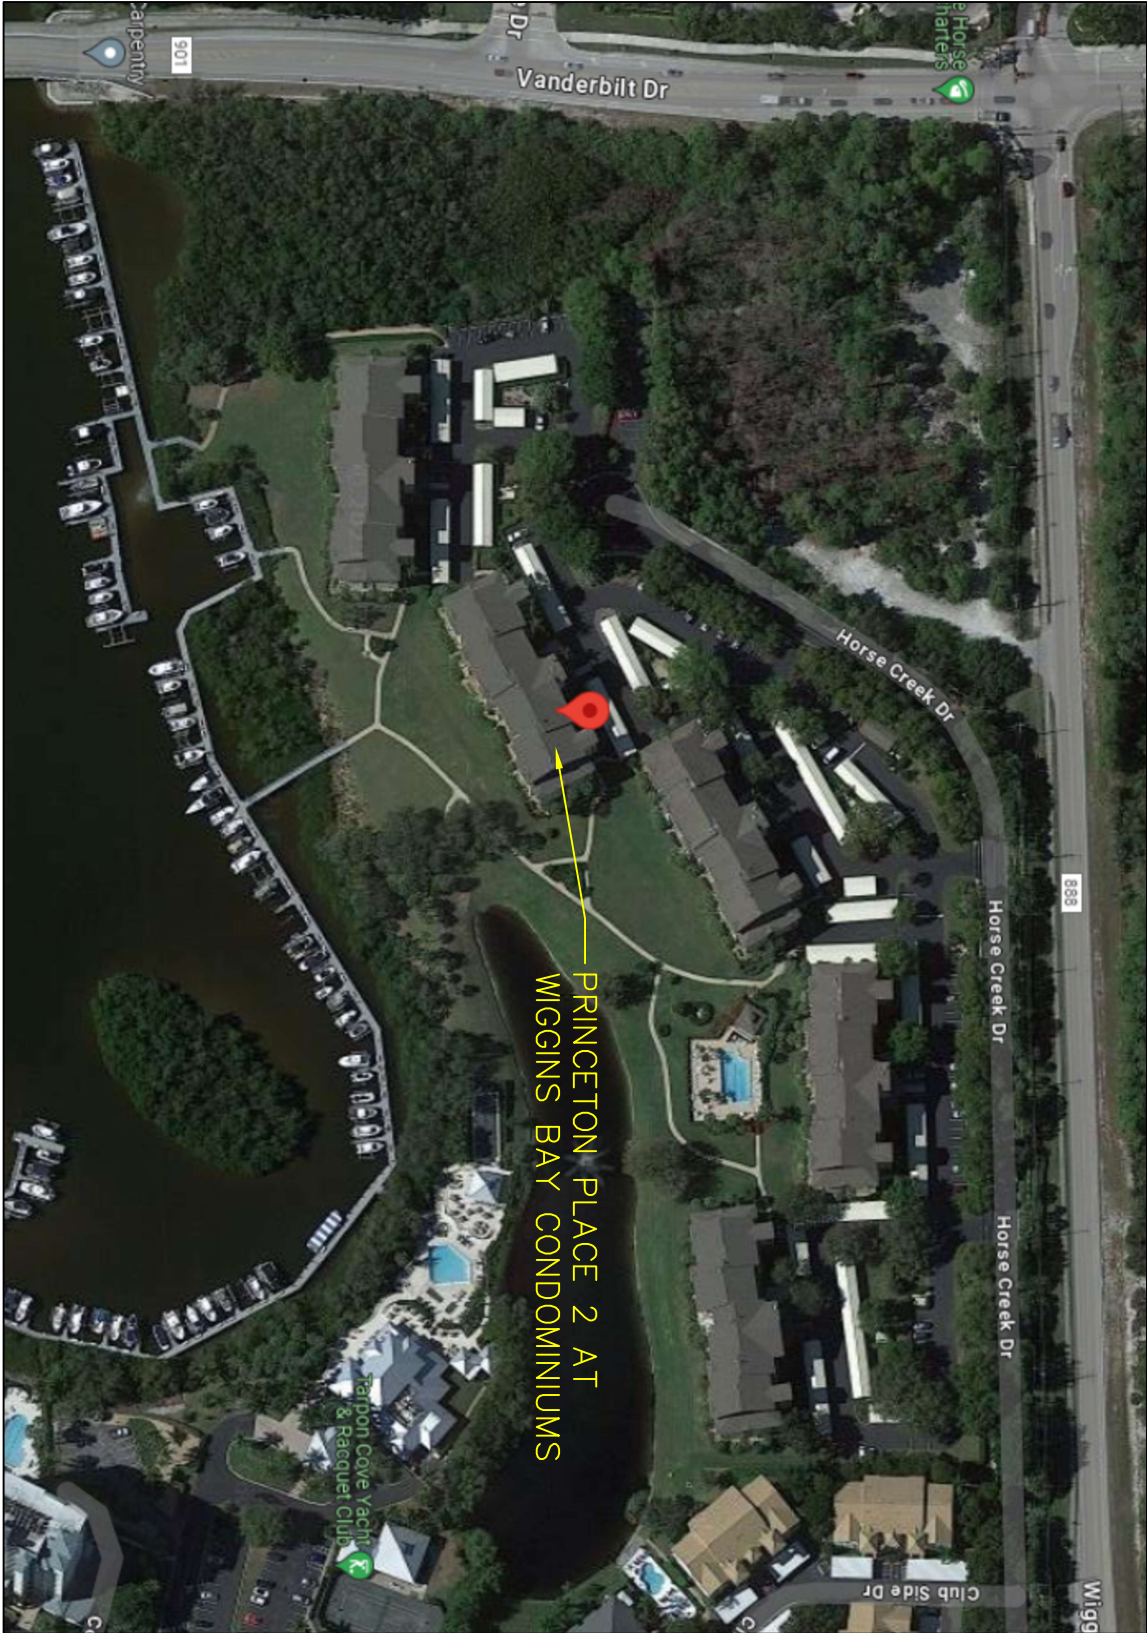
PRINCETON PLACE 2 AT  
WIGGINS BAY CONDOMINIUMS

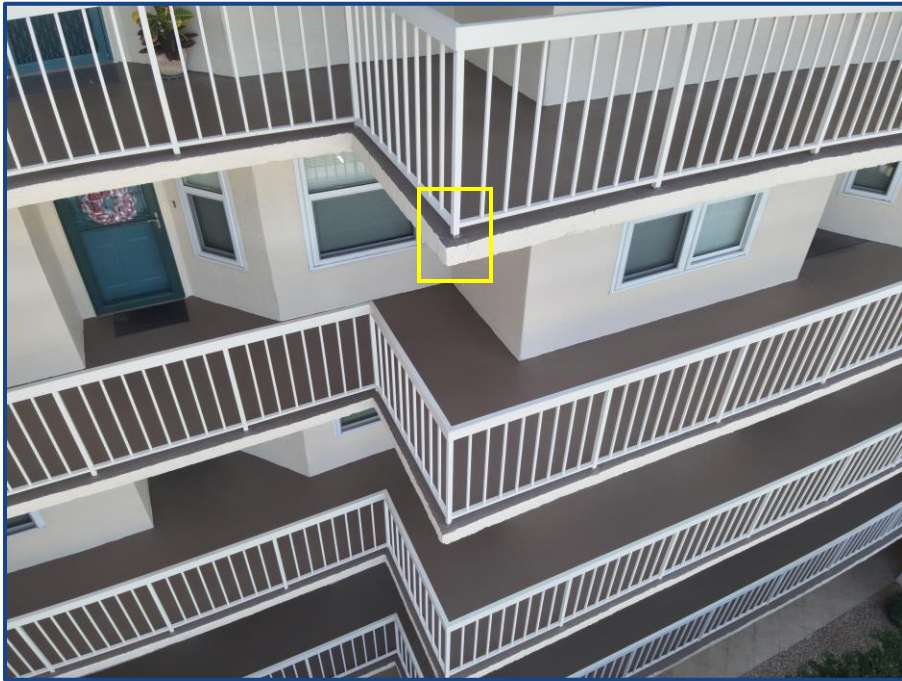
Photograph No. 8: General view of the exterior walkways and cracks/spalling in the exterior walkway corner on the fifth floor.

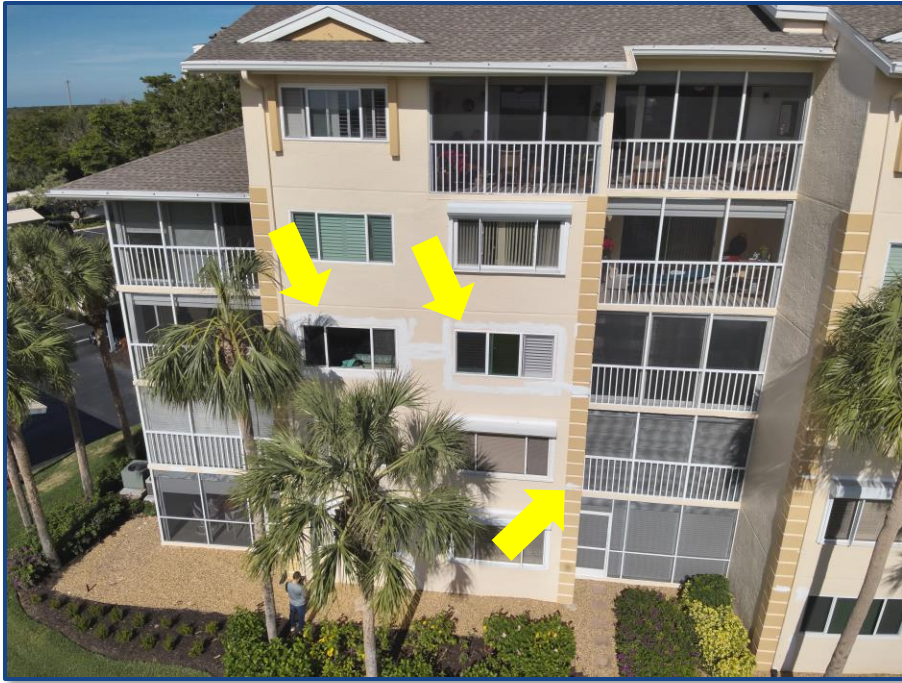
Photograph No. 9: View of previous patch repairs.

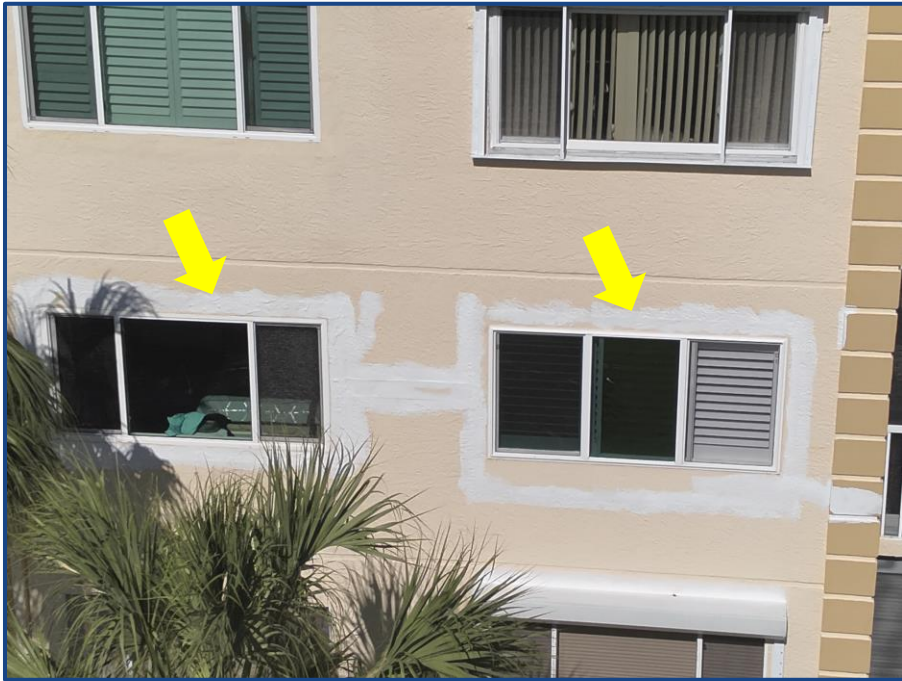
Photograph No. 10: View of previous patch repairs.

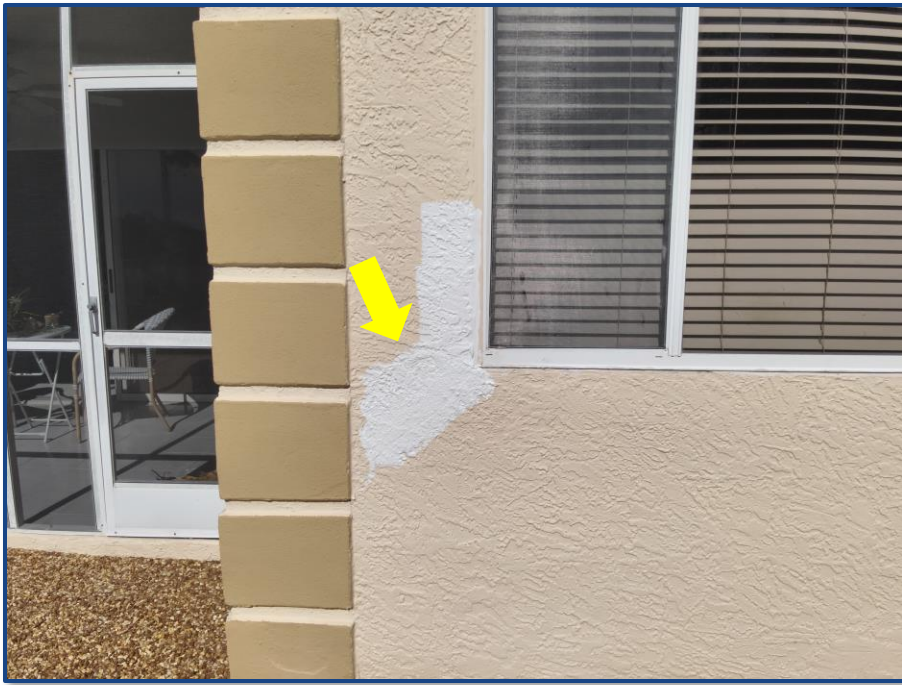
Photograph No. 11: View of previous patch repair.

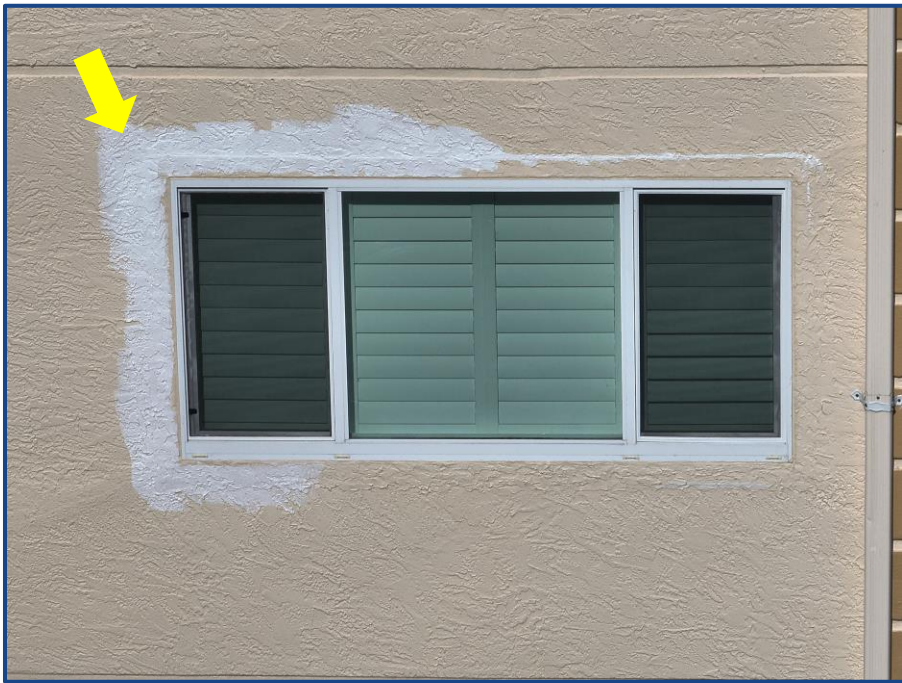
Photograph No. 12: View of previous patch repair.

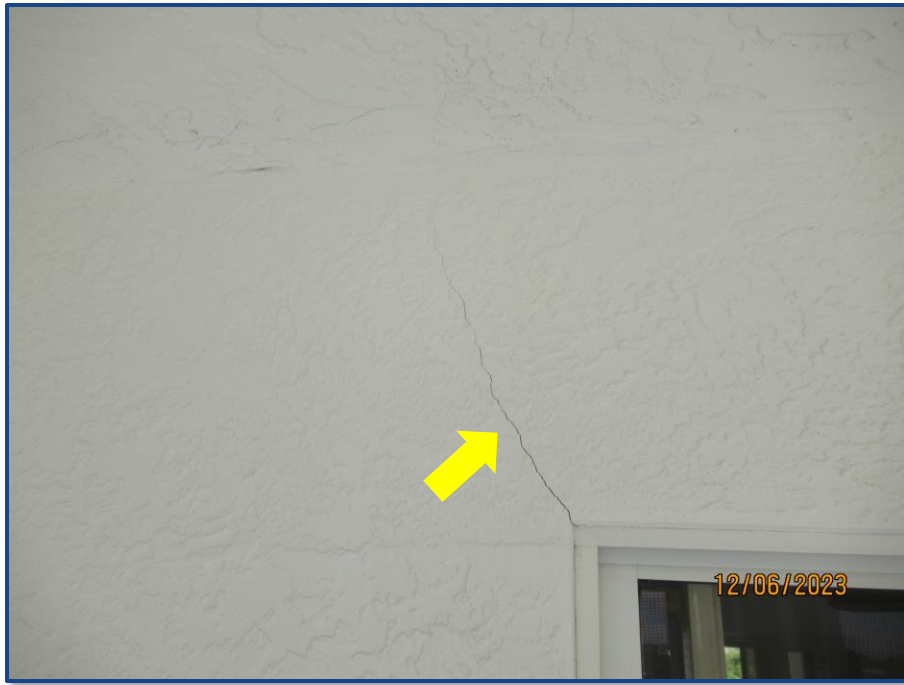
Photograph No. 17: View of crack in the exterior stucco wall finishes observed in the balcony of Unit 408.

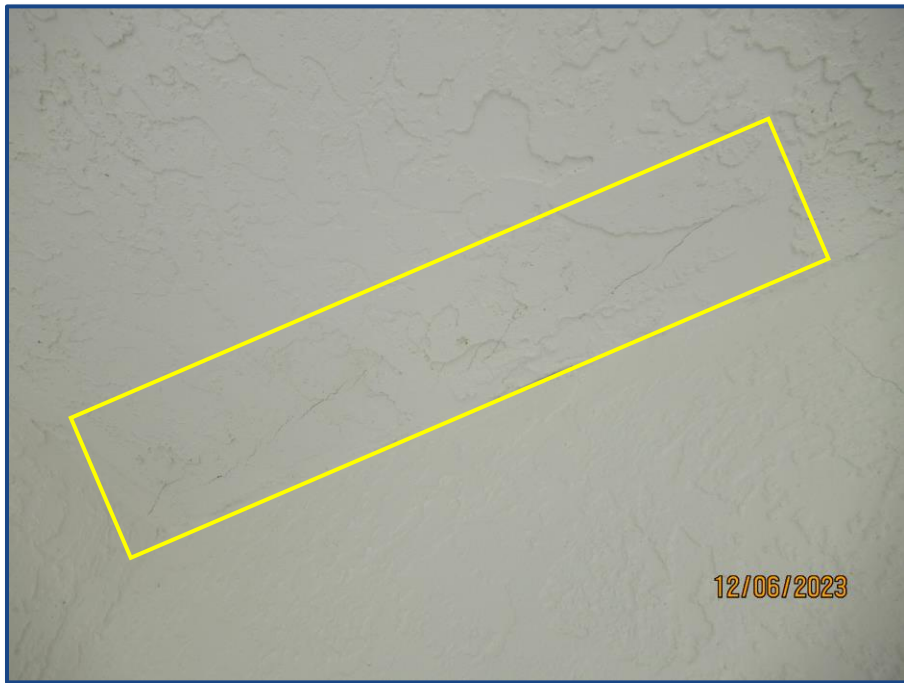
Photograph No. 18: View of cracks in the exterior ceiling finishes observed in the balcony of Unit 408.

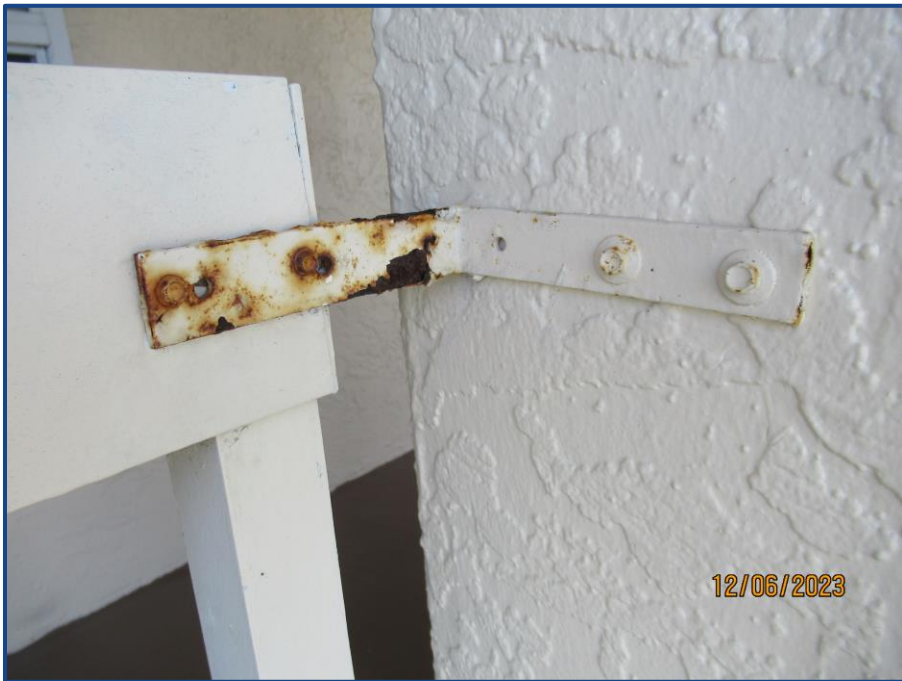
Photograph No. 24: View of corroded steel bracket observed on the 5th floor near the western end.

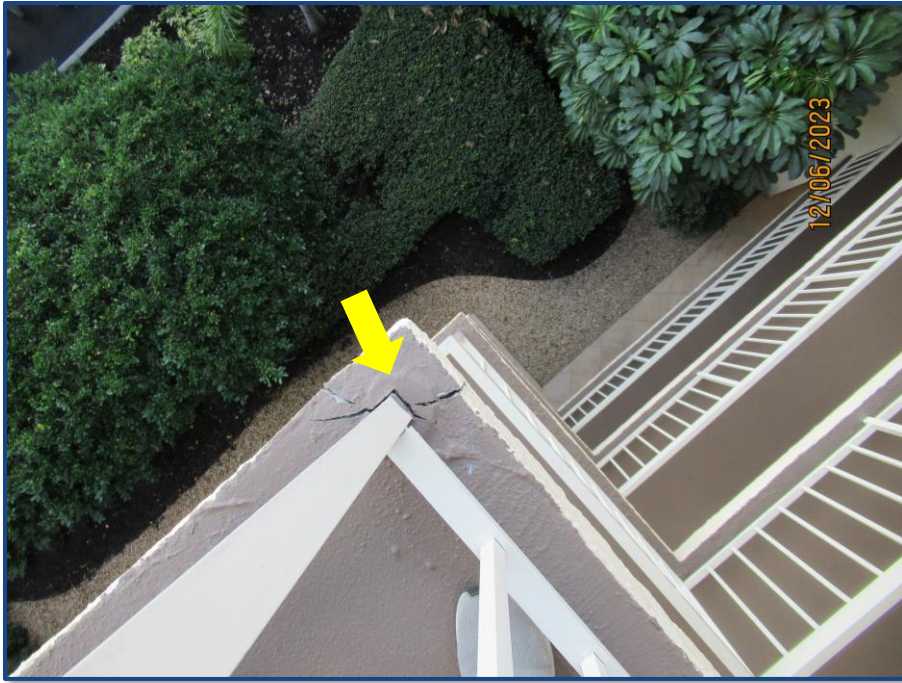
Photograph No. 25: View of cracks/spalling in the exterior walkway corner on the fifth floor.

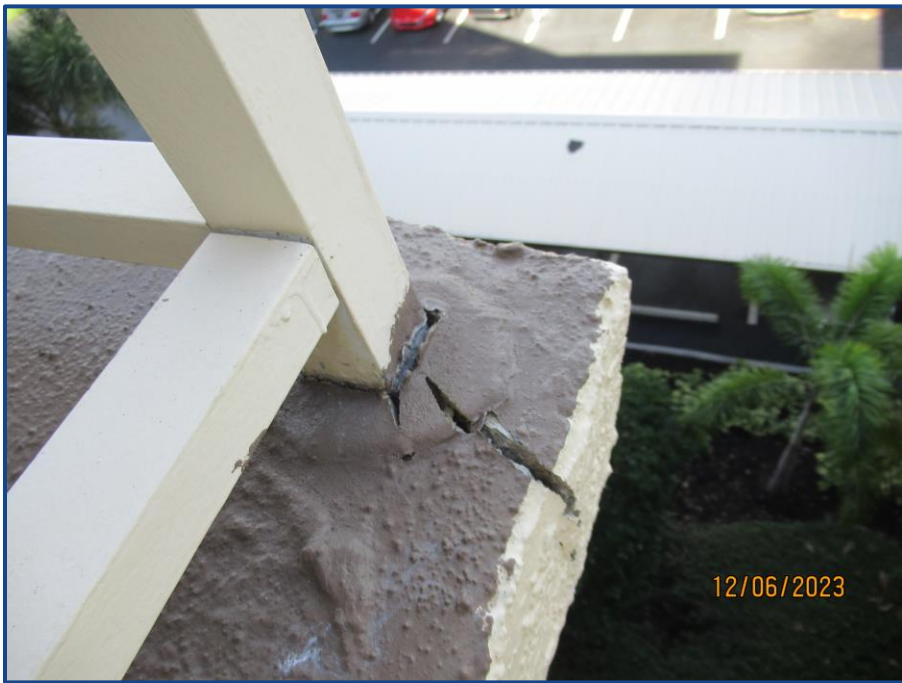
Photograph No. 26: Close-up view of Photograph No. 25.

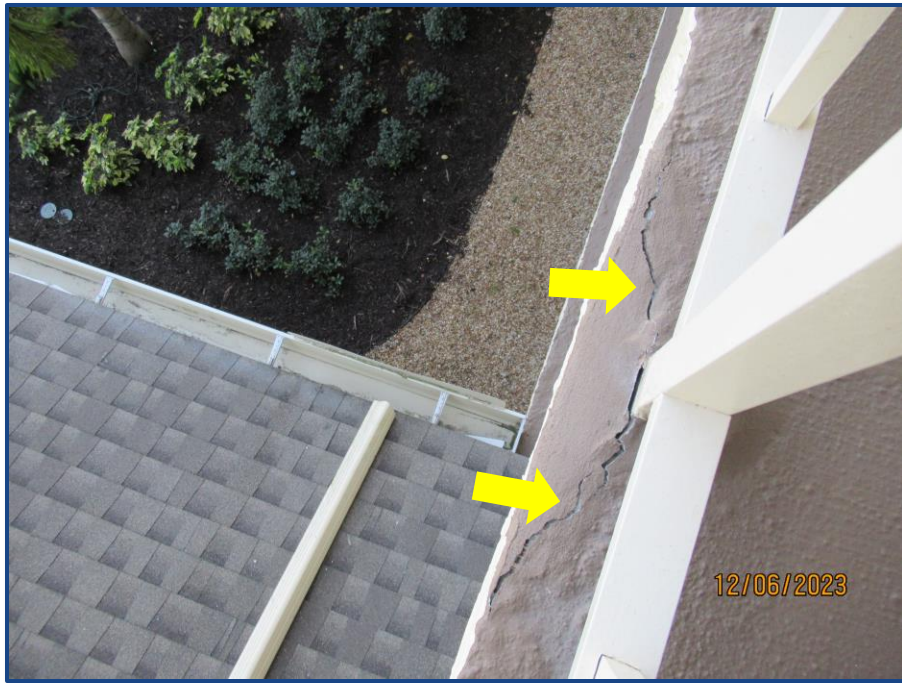
Photograph No. 27: View of cracks/spalling along the exterior walkway edge on the fourth floor.
