Re: Princeton Place 2 at Wiggins Bay Condominiums

Structural Integrity Reserve Study (SIRS)

320 Horse Creek Drive Naples, FL 34110

UES Project No: 0811.2300027.0000 – Task 17

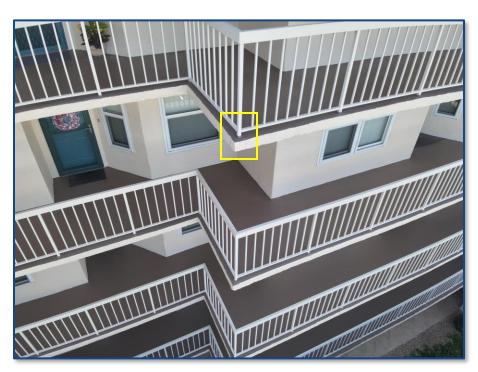
- Cracks/spalled concrete in the exterior walkways were observed at 5 locations. See Appendix C Photographs No. 8, 25 through 27.
- Exposed steel reinforcement was observed in the ceiling slab located in the electrical room in multiple locations. See **Appendix C** Photograph No. 14.
- Cracks in the exterior wall and ceiling finishes were observed in the balcony of Unit 408. See **Appendix C** Photographs No. 17 and 18.
- A corroded steel bracket was observed on the 5<sup>th</sup> floor near the western end. See Appendix C Photograph No. 24.
- An emergency light was not properly working and was observed in the eastern stairwell. See **Appendix C** Photograph No. 32.
- Peeling of the exterior walkway finishes was observed at an isolated location. See Appendix C Photograph No. 39.

Photograph No. 8: General view of the exterior walkways and cracks/spalling in the exterior walkway corner on the fifth floor.

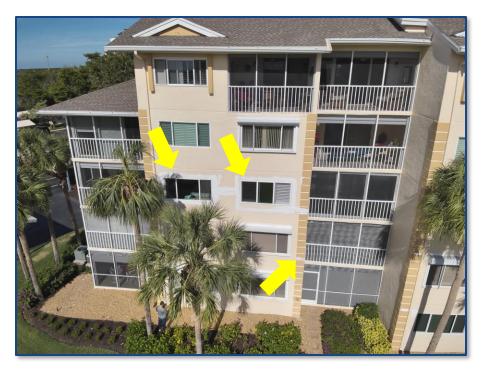
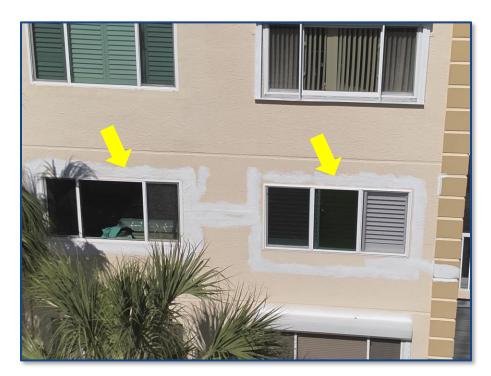
Photograph No. 9: View of previous patch repairs.

Photograph No. 10: View of previous patch repairs.

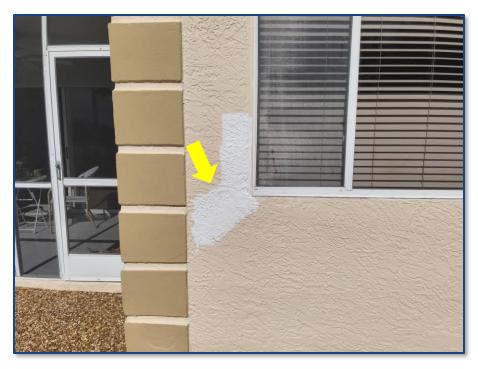
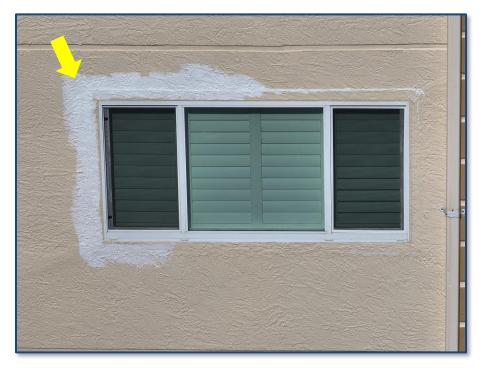
Photograph No. 11: View of previous patch repair.

Photograph No. 12: View of previous patch repair.

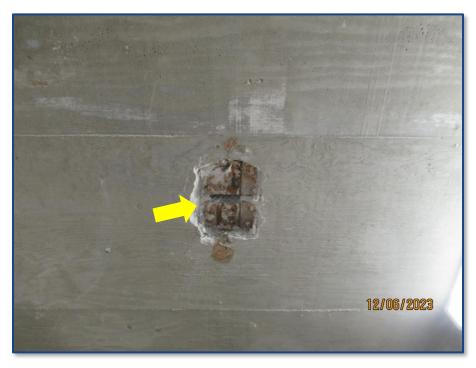
The building is composed of cast-in-place concrete load bearing walls, concrete beams, and reinforced concrete elevated slabs. At the time of inspection, cracks/spalling were observed in the elevated walkways at 5 locations. Additionally, exposed steel reinforcement was observed in the ceiling slab located in the electrical room in multiple locations. See **Appendix C** for referenced photographs.

Photograph No. 14: View of exposed steel reinforcement in the ceiling slab located in the electrical room.

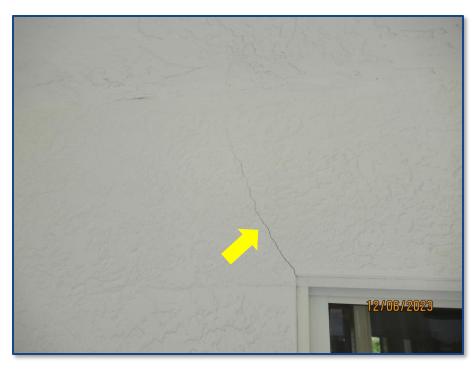
Photograph No. 17: View of crack in the exterior stucco wall finishes observed in the balcony of Unit 408.

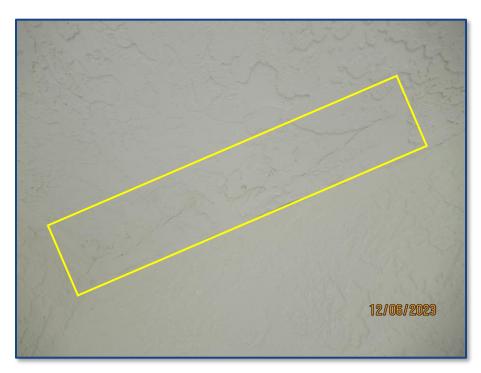
Photograph No. 18: View of cracks in the exterior ceiling finishes observed in the balcony of Unit 408.

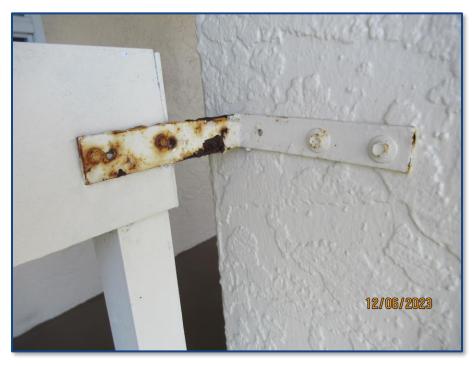
Photograph No. 24: View of corroded steel bracket observed on the 5th floor near the western end.

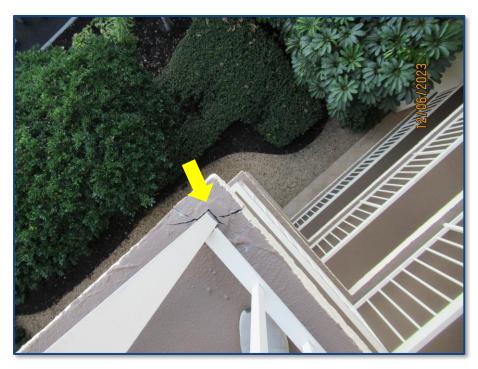
Photograph No. 25: View of cracks/spalling in the exterior walkway corner on the fifth floor.

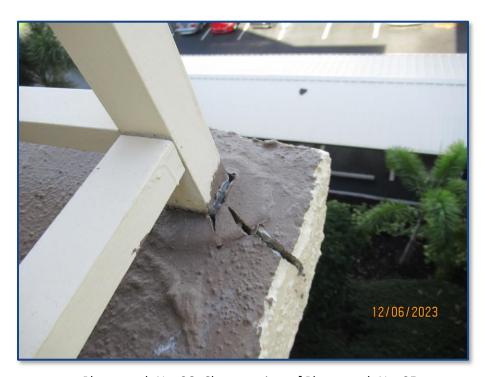
Photograph No. 26: Close-up view of Photograph No. 25.

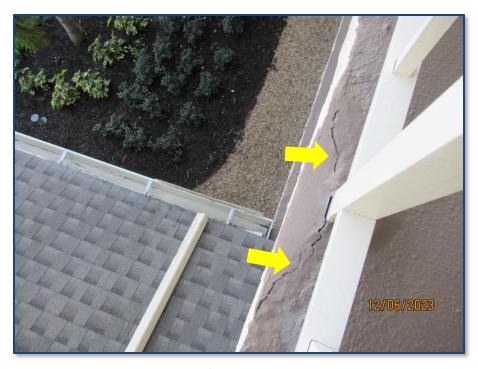
Photograph No. 27: View of cracks/spalling along the exterior walkway edge on the fourth floor.

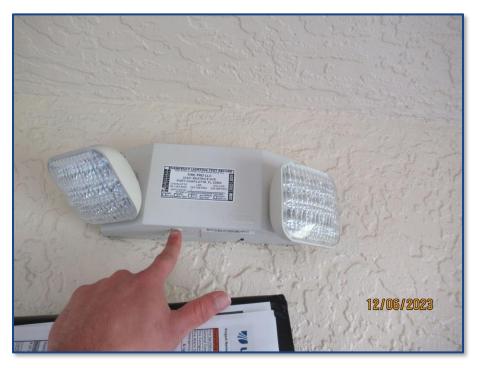
Photograph No. 32: Emergency light not properly working (eastern stairwell).

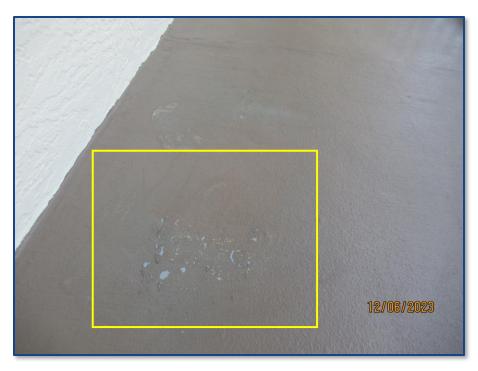
The common elevated exterior walkways are covered with an acrylic paint and were observed to be in good condition overall with peeling walkway finishes at isolated locations. The exterior finish of the building consists of painted stucco finishes. At the time of inspection, patch repairs were observed on the south elevation in multiple locations. Overall, the general condition of the exterior finishes is in good condition. See **Appendix C** for referenced photographs.

Photograph No. 39: Peeling of the exterior walkway finishes.

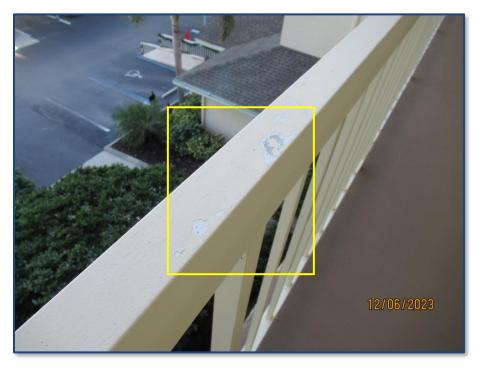
Photograph No. 40: Peeling of the paint in the exterior railing.

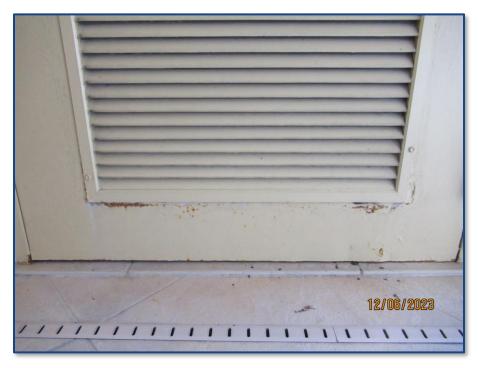
Based on UES's inspection the condominium has 11 common doors and no common windows. All doors with the exception of the elevator door were observed to be in good condition. The elevator door was observed to be corroded at the bottom of the door.

Photograph No. 42: Corrosion in the elevator room door.
